Understanding the structural response of masonry arch bridges through sensing

Assessing the current state and long-term prognosis of a Victorian viaduct

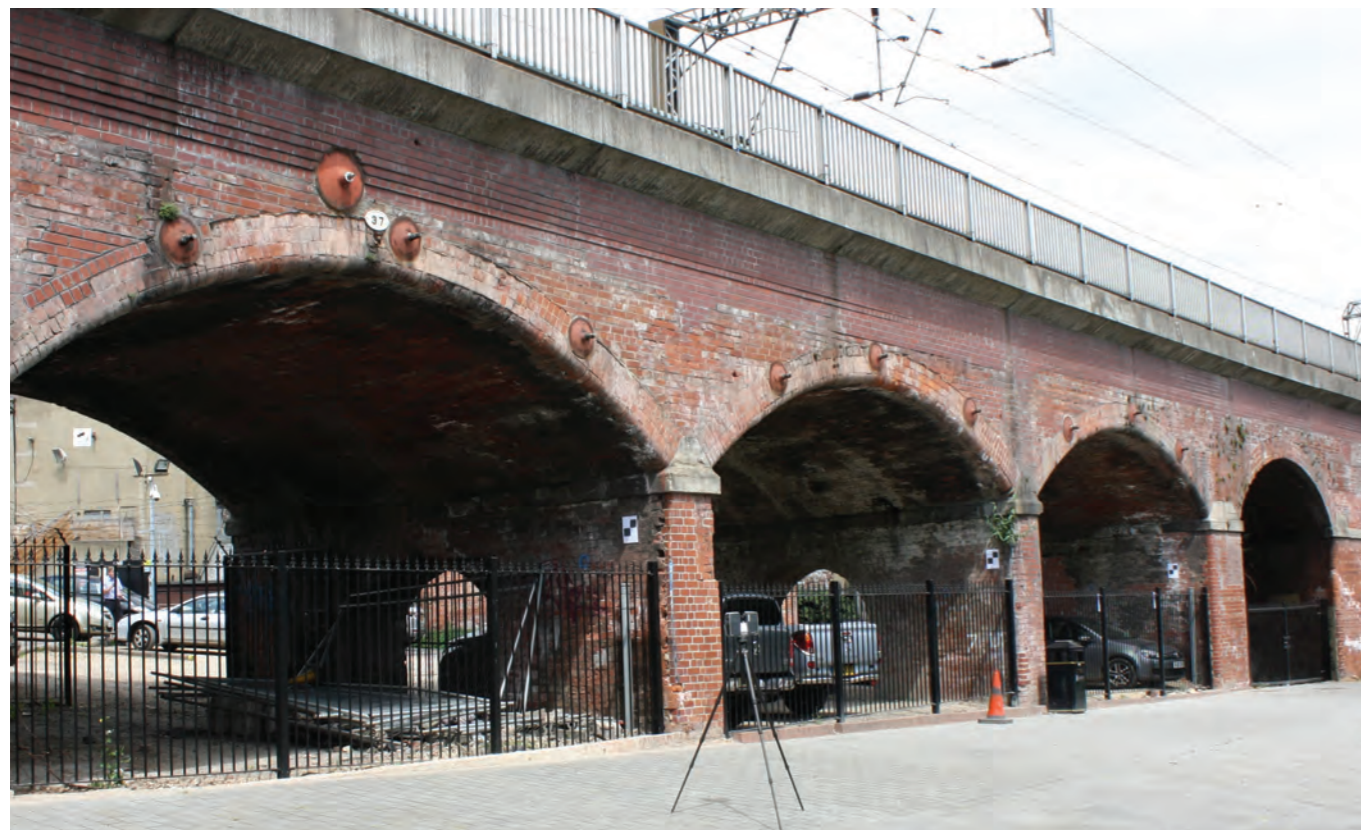
The monitored spans of the Victorian viaduct in Leeds

Working with industry partner Network Rail, CSIC has been monitoring an operational Victorian masonry arch viaduct in Leeds for the past two years. The objective is to better understand the dynamic response of the viaduct to rail traffic and identify the mechanisms that drive its degradation. The bridge is visibly damaged due to water leakage and past settlements and there has already been maintenance intervention. A speed restriction has been in place on the rail line. CSIC assessed the effectiveness of the existing intervention and whether the damage is progressively getting worse due to temperature cycles and dynamic loads.

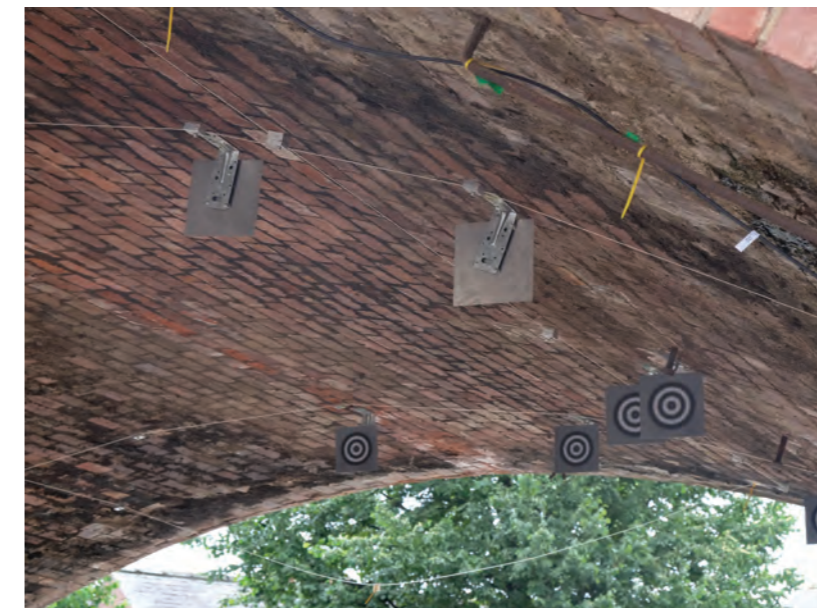
An arch instrumented with FBG cables and photogrammetry targets in the viaduct

The dynamic response, measured while trains pass over the viaduct, was monitored on two adjacent spans of the viaduct using a Fibre Bragg Grating (FBG) sensing system. To our knowledge, this marked the first ever deployment of FBG sensors in a masonry viaduct worldwide. Evaluation of the resulting fibre strain data was made possible with a novel non-contact videogrammetry solution, provided by Imetrum. The results demonstrated excellent agreement and highlighted the ability of fibre optic cables to detect very small strains to illustrate the flow of forces inside the structure.

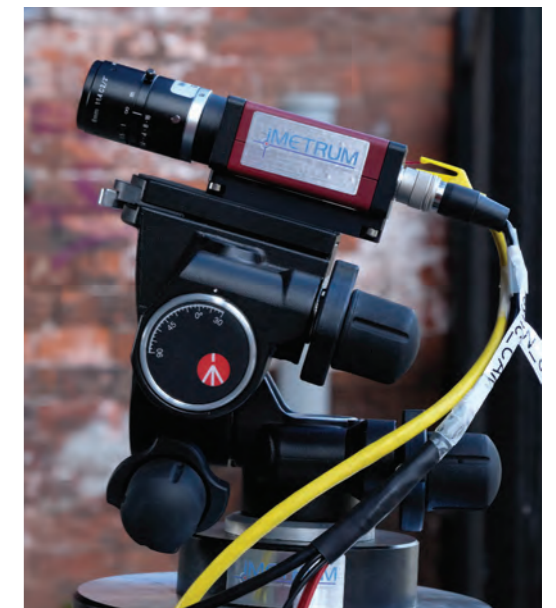
Imetrum videogrammetry camera
