Case Study

Analysis of Structural Health Monitoring Data from Hammersmith Flyover

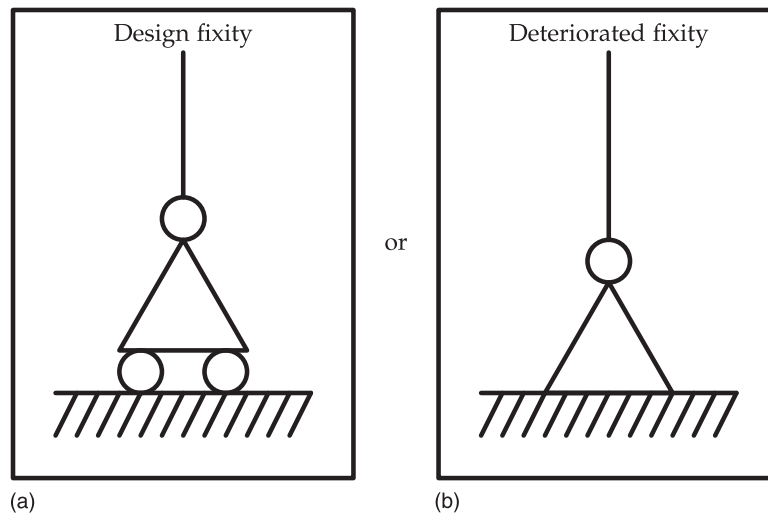
Fig. 4. (a) Symbolic representation of fixity of bridge roller bearing as designed and (b) possible actual operational fixity in the deteriorated state

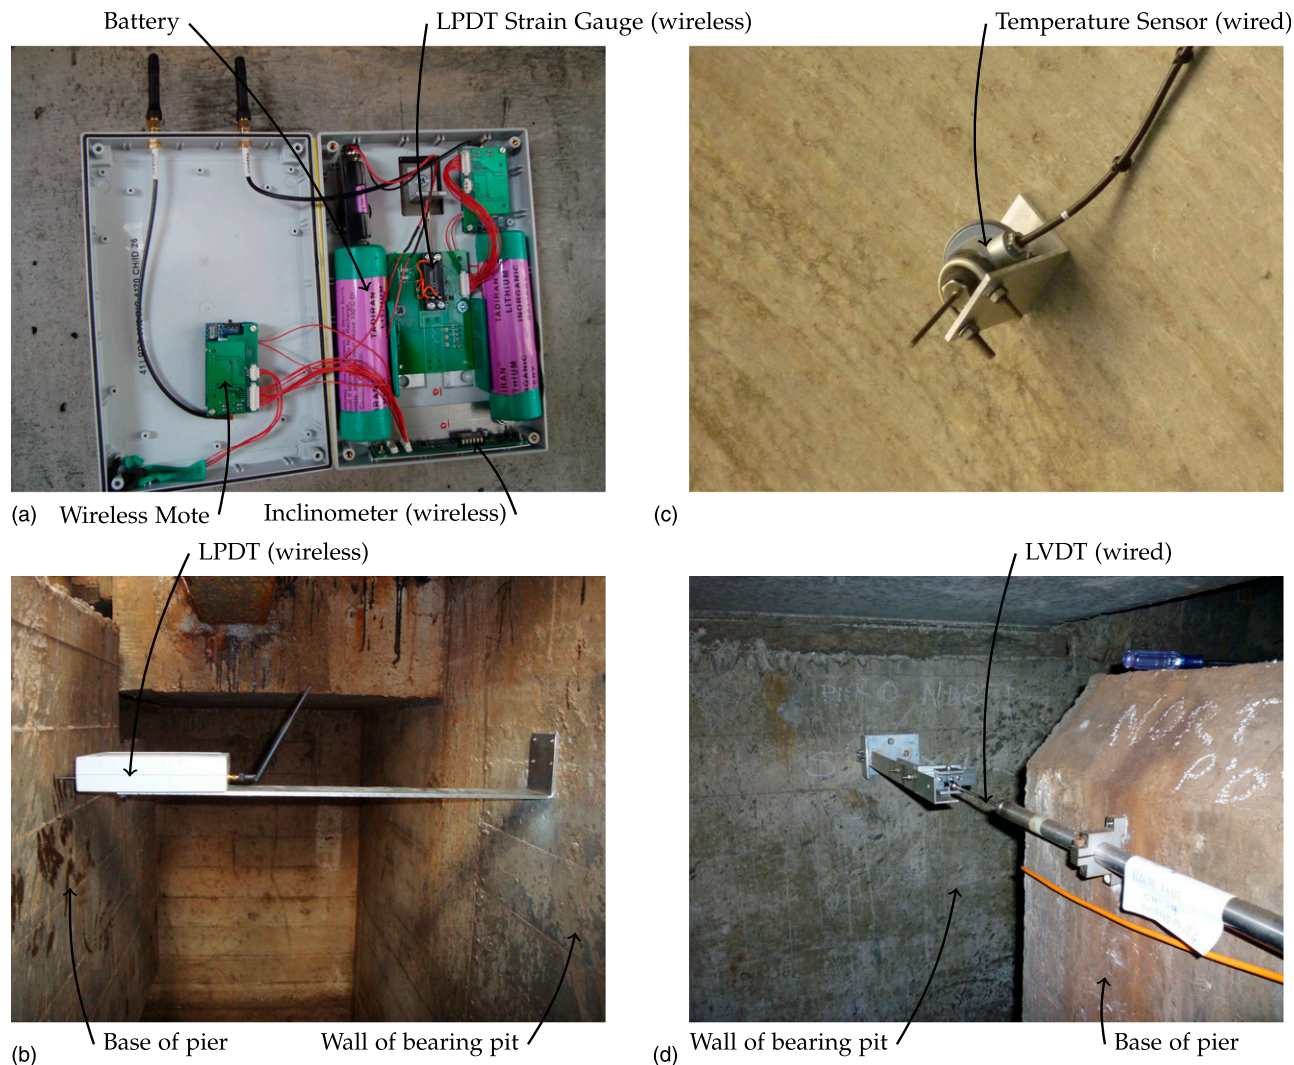
LPDT Displacement Sensors
A hardware circuit fault was identified in the LPDT sensor boards after installation. The actual board layout design used did not match the intended schematic. These boards had been designed very shortly before the field deployment and, as a result of time constraints, were installed without adequate calibration and testing, which would have revealed the fault. Eventually new circuit boards were designed and manufactured by the lead author and were installed in March 2012, replacing the faulty boards.

Fig. 6. Some sensors used in the monitoring study; photos taken on (a) August 26, 2009 (image courtesy of Dr. Peter Bennett); (b) September 22, 2009 (image courtesy of Dr. Peter Bennett); (c) February 8, 2011 (image by authors); (d) February 8, 2011 (LVDT = linear variable differential transformer; image by authors)

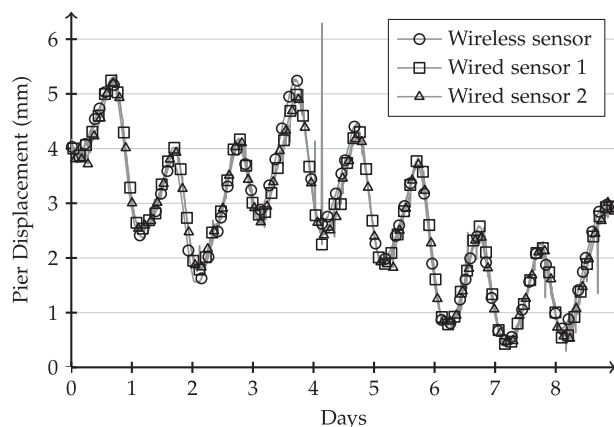
An analysis of some of the commercial sensor data is presented later in this paper. The only data from the Research System used in the analysis presented here are those obtained from the displacement gauges at the base of the piers, which enabled comparison between the data obtained from the commercial wired and research wireless SHM systems. Fig. 7 shows that the commercial and research

systems both provided very similar readings for displacement at the base of the piers.

Fig. 7. Comparison of data from commercial wired and research wireless monitoring systems (start date March 22, 2012)

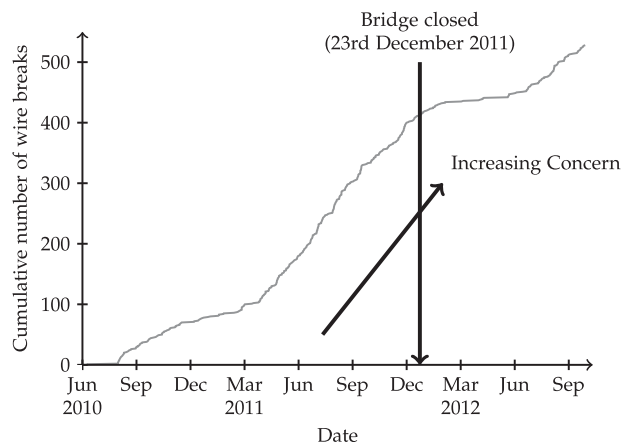
Fig. 8. Cumulative wire breaks in all spans (2010–2012)

The commercial AE system was installed with the aim of detecting wire breaks in the prestressing tendons in the deck box section. Fig. 8 shows a cumulative plot of the number of wire breaks detected throughout the whole bridge by the AE system over approximately 2 years. Investigations following from the results of the AE monitoring led to the closure of the bridge for emergency repairs on December 23, 2011. It might be expected that losses of prestressing force would result in a change in longitudinal strain in the bridge deck. The installed monitoring systems included a limited number of gauges at critical sections measuring longitudinal strain in the deck, and a study was undertaken by the University of Cambridge research team to determine what magnitude of strain is caused by different levels of prestress loss, although it was anticipated that these strains would be very small.

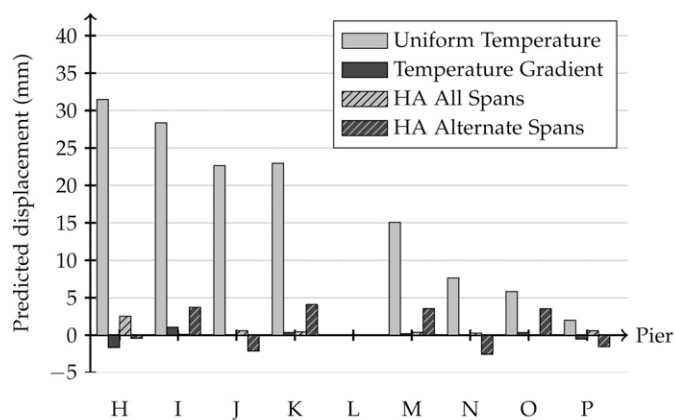
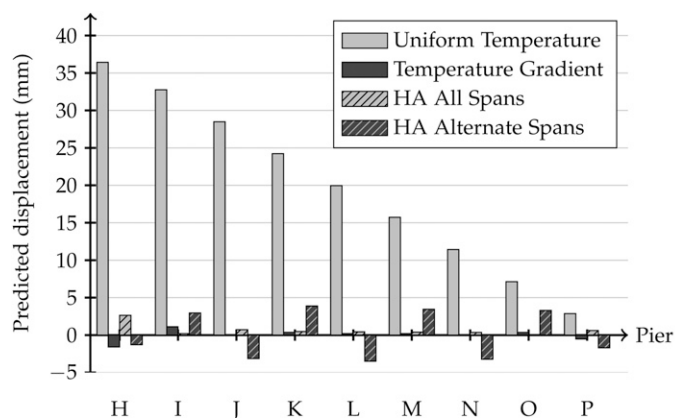
Fig. 13(a) shows the predicted displacements for each pier for each of these load cases when all bearings are functioning correctly

Fig. 13. Predicted displacements for various load cases: (a) all bearings free; (b) one bearing pinned (at pier L), others free (HA loading is defined in Table 1)

Subsequently, the analyses were repeated with the support at one pier (pier L) assumed fixed to prevent any longitudinal displacement, simulating a corroded and jammed bearing. In Fig. 13(b), it can be seen that, with the exception of pier L, the predicted displacements of the piers are very similar to those shown in Fig. 13(a) (the undamaged scenario). Repeating the aforementioned analysis with any other pier assumed fixed results in a similar outcome. This means that deterioration of one of the bridge's bearings is not expected to significantly alter the displacements measured at the other piers. This should make it possible to determine the state of any bearing if the correlation between temperature and movement is no longer present.

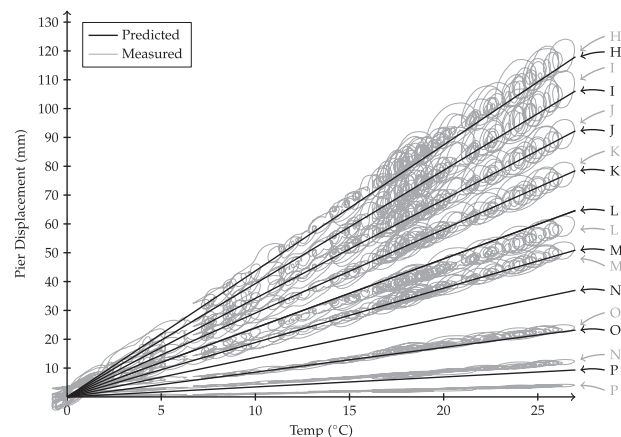
For each pier, there appears to be a good linear relationship, suggesting that pier displacements are caused predominantly by temperature changes, as expected. A hysteresis effect can be seen, caused by the thermal mass of the bridge taking time to react to temperature changes. The actual measured displacements of seven of the piers (H, I, J, K, L, M and O) compare very well with the predictions, whereas piers N and P do not. Although these two piers move with temperature variations, they do not move to the same extent as would be expected from the modeling predictions. This implies that the bearings for these piers behave as if partially restrained and do not allow completely free longitudinal movement. No access to pier P was available to the authors; however, inspection of the bearings at pier N revealed the cause at that location. In each bearing pit, in addition to the bearings supporting the pier, there are also four steel plinths designed to prevent catastrophic damage occurring if any of the bearings were to fail by only allowing the pier to drop by a few millimeters. During construction, metal shim plates were inserted between the top of the plinths and the base of each pier to maintain a gap of approximately 13 mm (Rawlinson and Stott

Fig. 14. Predicted and measured longitudinal displacement versus temperature plots for piers H to P

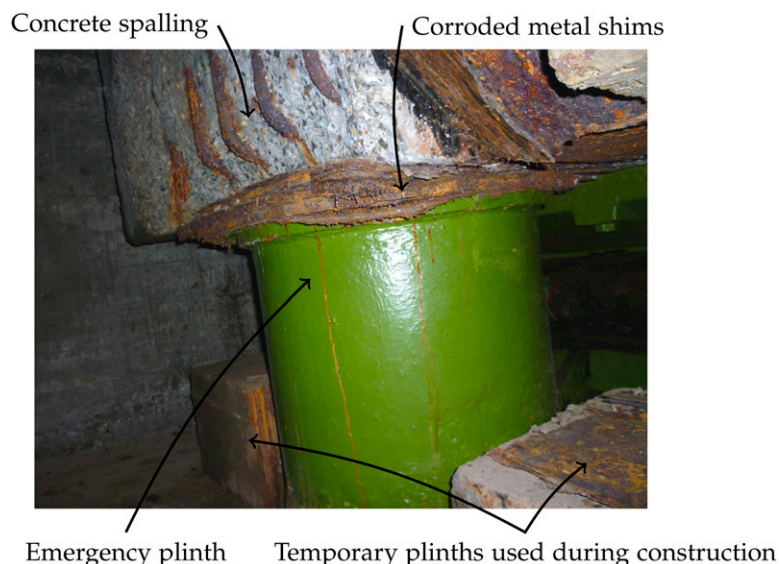
Fig. 15. Base of pier N showing metal shims (image by authors, taken February 8, 2011)

1962). Fig. 15 shows pier N in 2012 with the shims in place but they have corroded over the last 50 years and become wedged between the pier and the plinth, restricting horizontal movement of the pier.

4. Measurements from both the Commercial and Research Systems have indicated that two of the flyover's pier bearings are partially restrained, rather than freely allowing longitudinal movement as had been intended by the designers; this was verified in the case of one pier (pier N) by visual inspection.
