Fibre optic sensing systems for safer real-time rockfall monitoring of rail cuttings

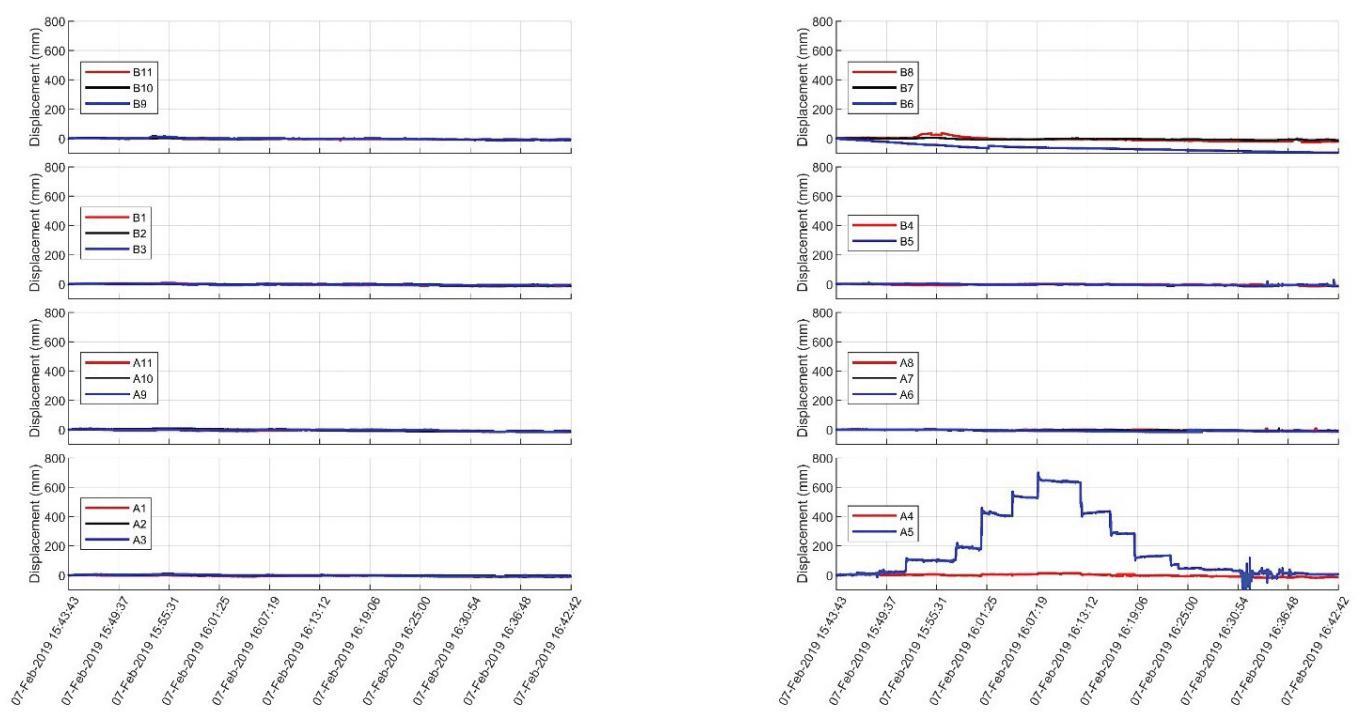
Real-time monitoring at Hooley Cutting.

The sensor cables were routed to a control room where the two optical analysers were located. Once the system was established, the system could report the location of any change in strain of the mesh, which could indicate accumulation of debris. Dynamic measurements from the FBG sensing system were sampled at a 10Hz frequency and the raw data files from these measurements were transferred over the network for processing. This work is led by CSIC Research Associate Dr Xiaomin Xu.

In order to test the sensitivity of the system, a trial was carried out in February. The trial was carried out using a tirfor winch to lift the mesh in a controlled way. The tirfor was anchored at the top of the slope, on the crest, while its hook was attached to the mesh at a location close to the fibre optic cables. The figure below shows a snapshot of the strain change histories, measured with the various FBG sensors during the trial of the system. Each chart plots the strain measured at two or three locations on the slope. As seen, stretching of the mesh near sensor A5 results in highly localised strain, while other gauges remain mostly unaffected.
